Nippon Shokubai Co., Ltd. Himeji Plant

Explosion and Fire at Acrylic Acid Production Facility

Investigation Report

March 2013

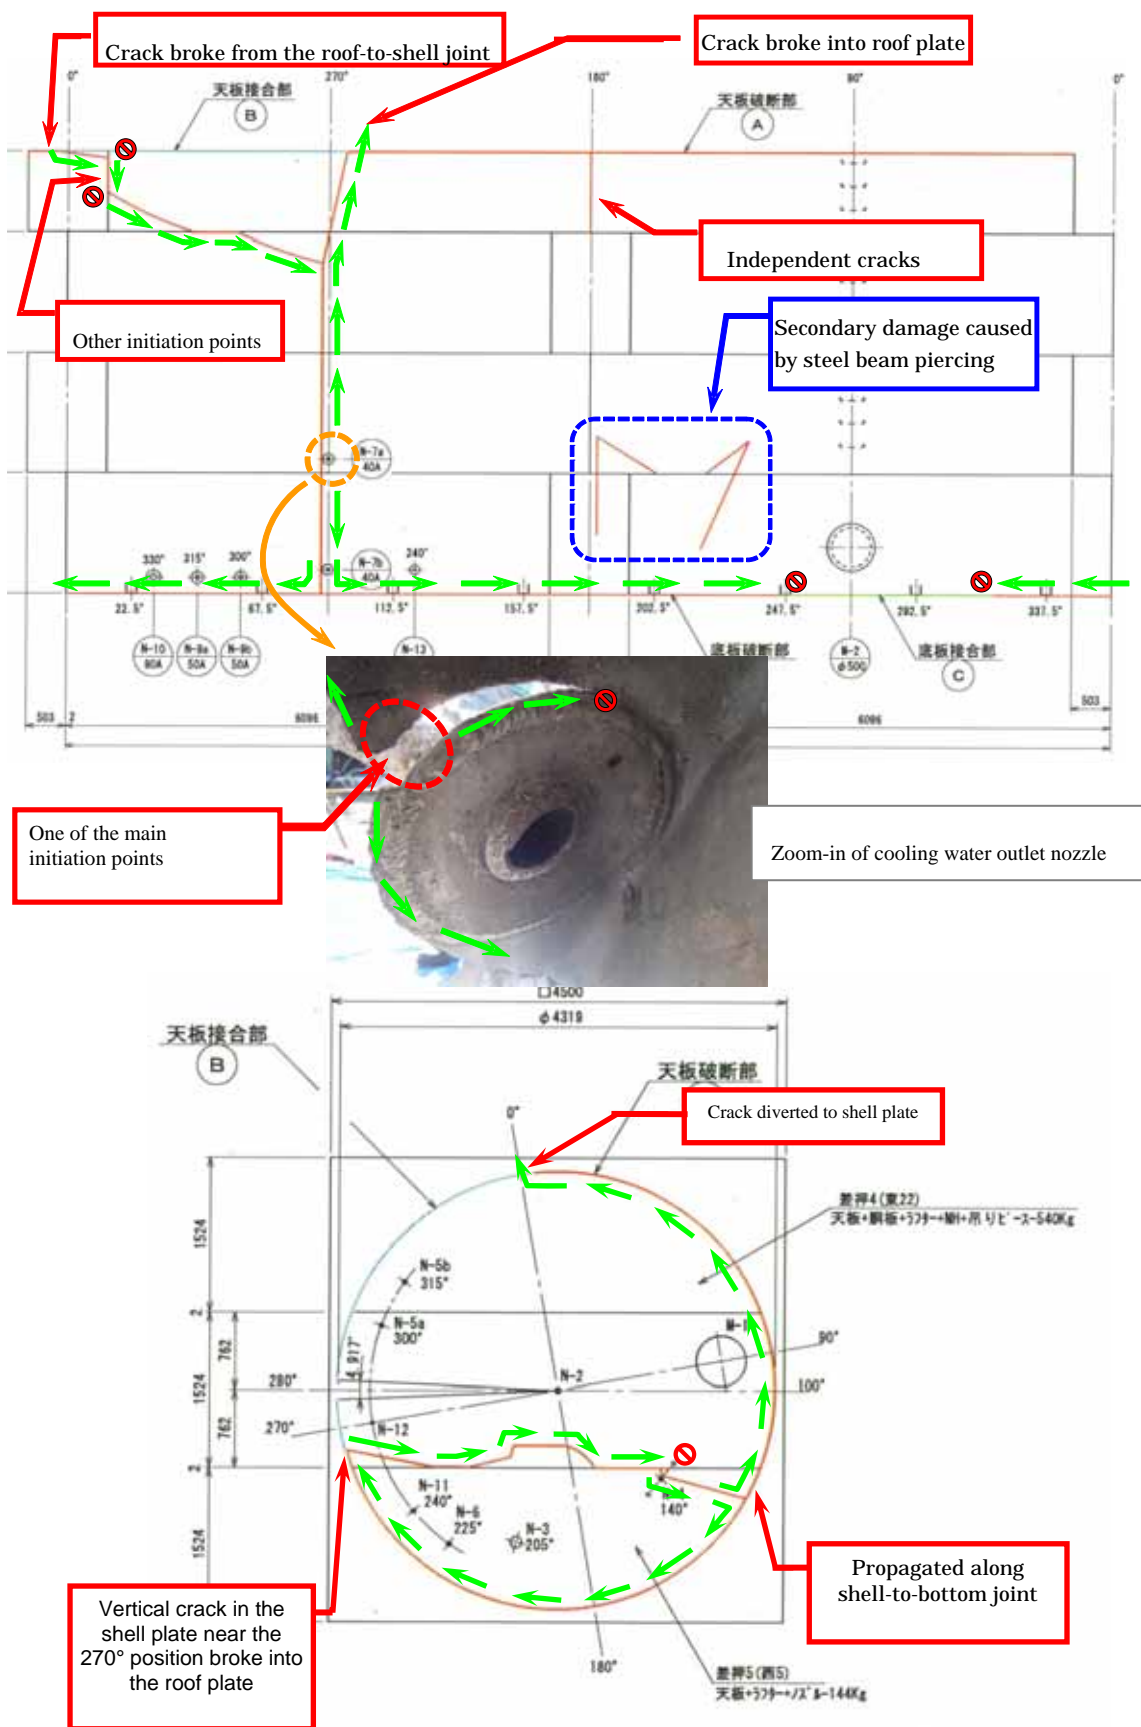
(Figure 4-10) V-3138 crack initiation and estimated propagation paths (top/ shell plates development view)

The cracks formed in this part propagated and split the tank shell plate vertically in both directions at 270° position. The upwards crack broke into the roof plate and ran through it near the 135° position. The roof and bottom plates generally cracked in the circumferential direction near their joints with the shell plate. Figure 4-10 shows the estimated crack propagation paths of the roof and shell plate in development view.

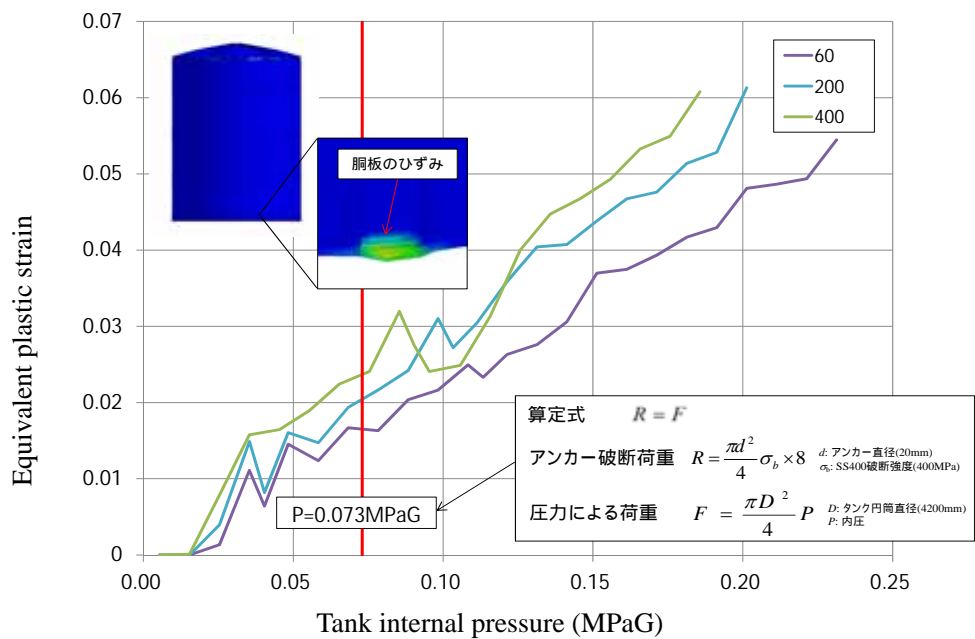
(Figure 4-13) Equivalent plastic strain on the tank surface caused by the tank internal pressure

Figure 4-13 shows the equivalent plastic strain on the tank surface caused by the tank internal pressure. Figure 4-14 shows the vertical reaction force acting on the anchors as a result of the tank internal pressure. The lower limit for the tank pressure to create the anchor breaking load of 1005kN was 0.073MPaG. The tank pressure at which the vertical reaction force exceeds the breaking load was estimated to be about 0.1MPaG. However, the strain on the shell plate at that time was about 2~3% which was not a level rupture would occur at the shell plate.

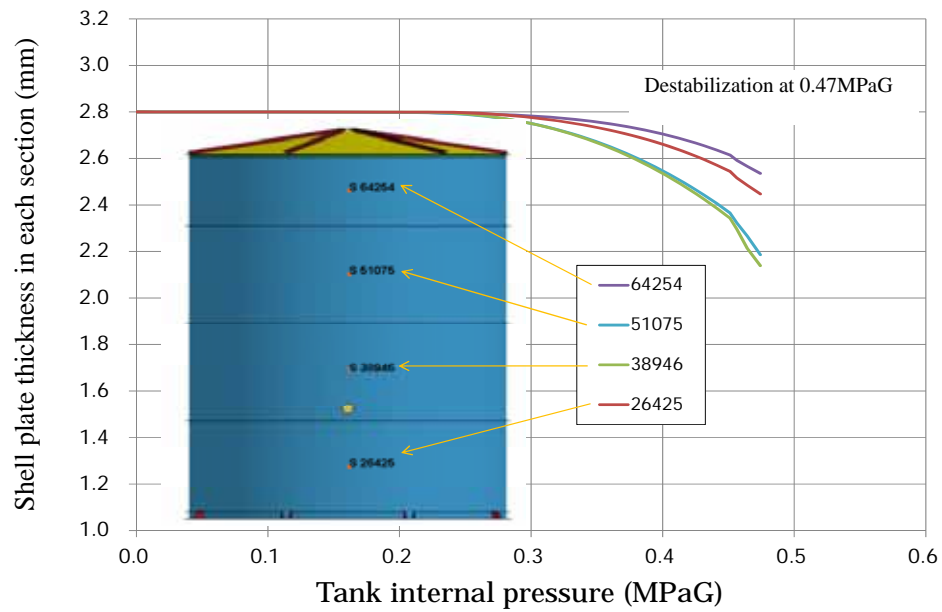
(Figure 4-15) Plate thickness reduction against the tank internal pressure by 3-D model (at 200°C)

The thickness of the ruptured V-3138 shell plate measured at about 2.8mm which was the same thickness as at the time of manufacture. Because of this, it was presumed that plate thickness reduction, which begins when the elastic limit of the material is exceeded, had not occurred. The pressure at which plate thickness reduction would become noticeable was estimated at about 0.25~0.30MPaG through structural analysis using the 3-D model. Figure 4-15 shows the results of plate thickness reduction against the tank internal pressure.
