Accident Investigation Committee Interim Report

January 18, 2013

Accident Investigation Committee

At about 14:35 on September 29, 2012, an explosion and fire occurred in an intermediate tank (equipment item number: V-3138; nominal capacity: 70 m³) that temporarily stored bottom liquid from the glacial acrylic acid rectifying column at Nippon Shokubai's Himeji Plant. The fire then spread to the nearby acrylic acid tanks, toluene tank and fire engines.

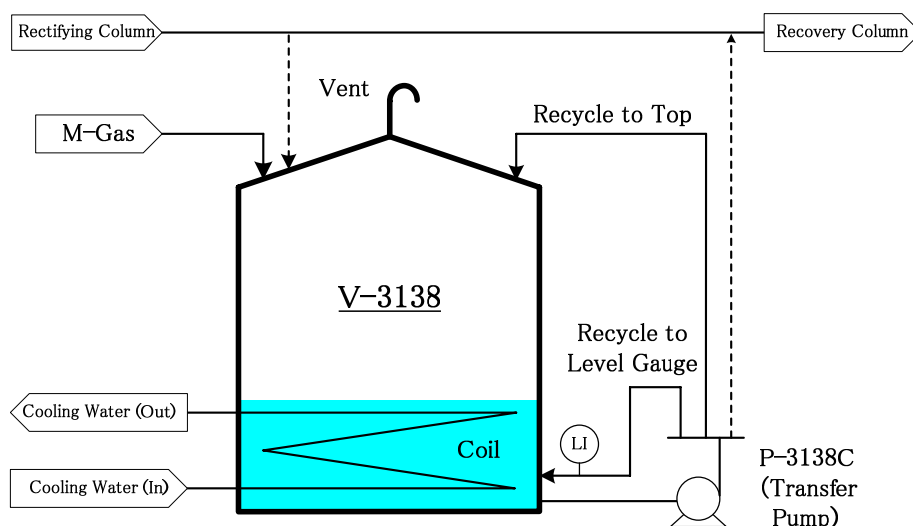
Figure 2. Schematic of tank V-3138

- The intermediate tank V-3138 has a 70 m³ nominal capacity with a cone roof. It was installed in November 1985.
- It is an intermediate tank used for temporarily storing bottom liquid from the rectifying column when for example the rectifying column stopped. During normal operation, the bottom liquid is fed directly into the recovery column without passing through V-3138 and therefore, the intermediate tank is kept stagnant.

- There was a cooling water coil inside V-3138 that serves to prevent freezing of acrylic acid and cool the liquid that was fed into V-3138. The amount of liquid necessary to fully cover the top of the coil is 25 m³.

- V-3138 liquid is circulated through pump P-3138C back into the same tank at two locations: liquid level gauge nozzle set near the lower side of tV-3138 wall (referred to as “Recycle to Level Gauge”) and nozzle set at V-3138 top (referred to as “Recycle to Top”).

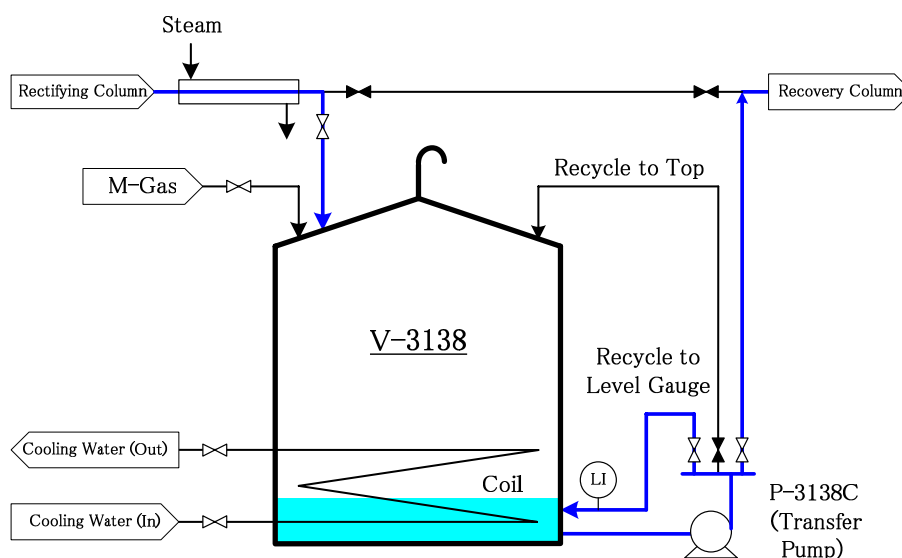
Figure 3. Status of tank V-3138 before liquid storing

- On September 24, the operation was switched to feed the rectifying column bottom liquid into V-3138, and from V-3138, the bottom liquid was fed from V-3138 into the recovery column. During this operation, the liquid volume in V-3138 was maintained constantly at about 10 m³.

- The transfer piping of rectifying column bottom liquid was steam jacketed to prevent plugging due to precipitation. The temperature of the bottom liquid as it enters V-3138 was estimated at about 100°C, based on steam temperature and the length of the jacketed piping.

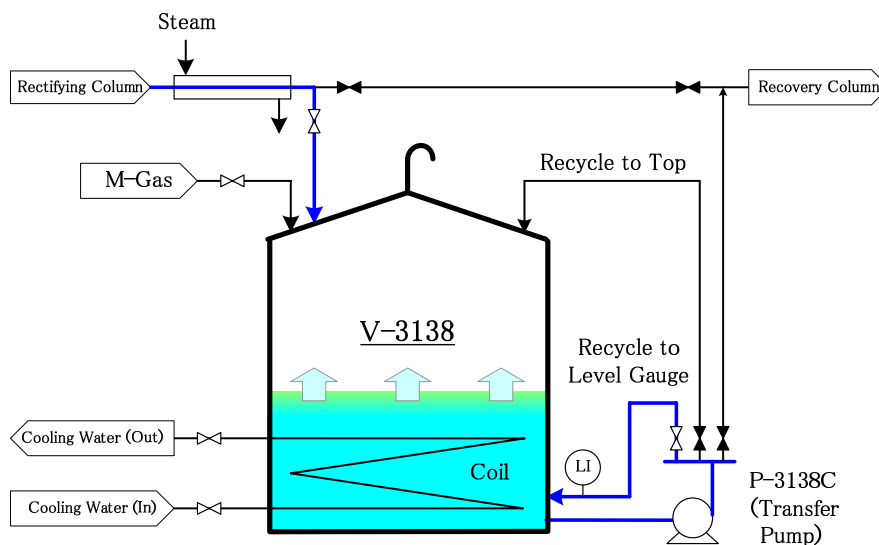
Figure 4. Status of tank V-3138 during liquid storing

- At about 9:30 on September 25, the feed of bottom liquid from V-3138 to the recovery column was stopped and commenced to build up the liquid volume in V-3138. This was to prepare a capacity load up test in the recovery column which was scheduled at a later date.
- There was no particular change in the crude acrylic acid fed to the rectifying column or in the inhibitors. Similarly, there was no abnormality observed in the operation conditions.
- The volume of liquid in V-3138 reached 60 m³ at about 14:00 on September 28, approximately 77 hours after the commencement of storage. During this period, the circulation of Recycle to Top was not commissioned.
- The cooling water coil cooled the liquid in the bottom of V-3138 but was unable to cool the liquid above the top of the coil effectively. This had created an uneven temperature distribution in the

vertical direction of V-3138 liquid. It is presumed that this relatively high temperature section had gradually led to reaction forming acrylic acid dimer (diacrylic acid, referred to as “DAA”). With the heat of this reaction, V-3138 liquid temperature has increased steadily.

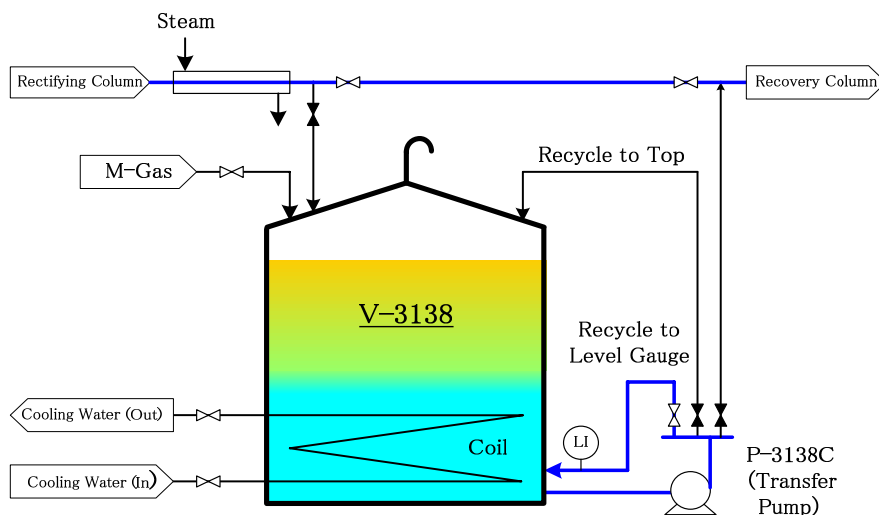
Figure 5. Status of tank V-3138 after liquid storing

- At about 14:00 on September 28, the liquid volume in V-3138 reached 60 m³. Hereafter, the rectifying column bottom liquid was switched back to feed the recovery column directly without passing through V-3138.
- Even then, the circulation of Recycle to Top was still not commissioned. Consequently, the liquid above the top of the coil was not cooled and remained at a relatively high temperature.
