Nippon Shokubai Co., Ltd. Himeji Plant

Explosion and Fire at Acrylic Acid Production Facility

Investigation Report

March 2013

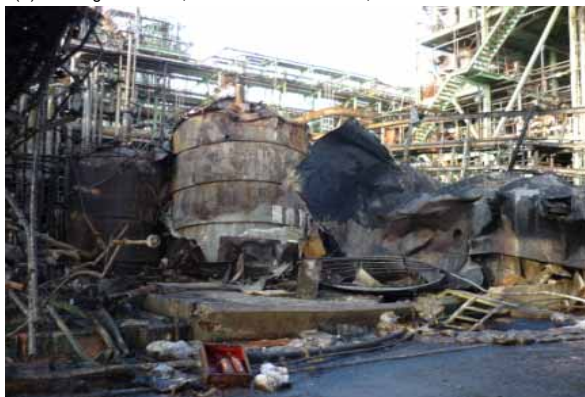
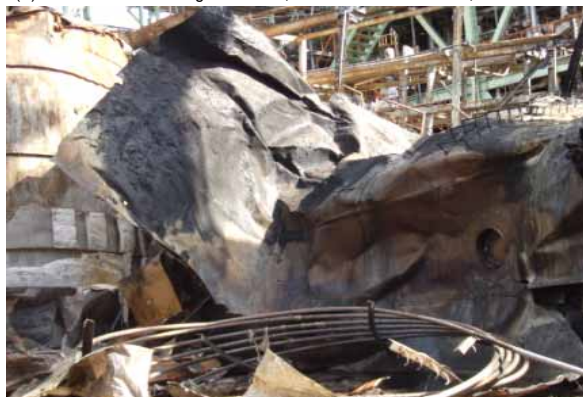
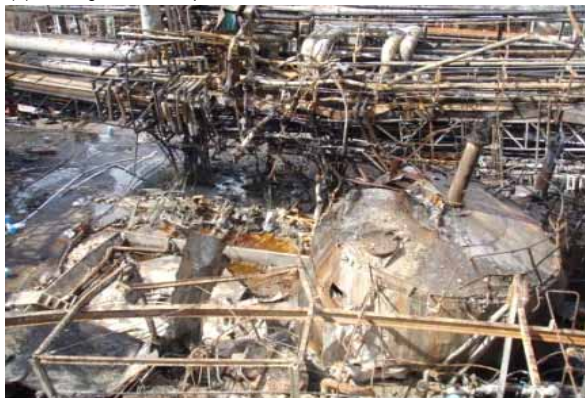
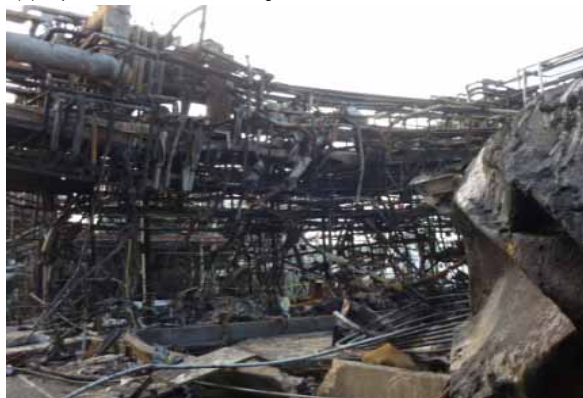
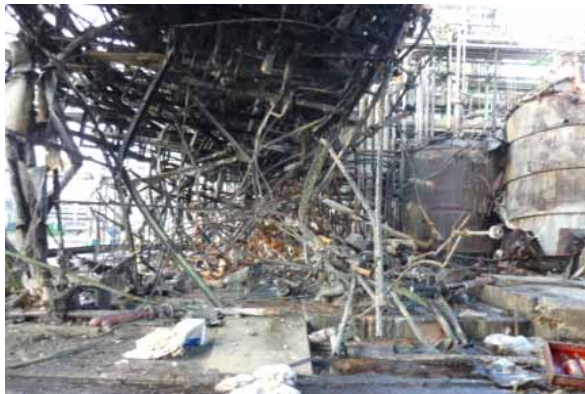
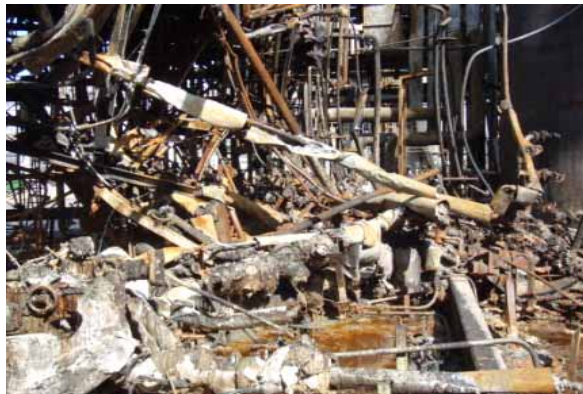
(Figure 4-8) Damages around V-3138

The Figure 4-8 shows the ruptured V-3138 resulted from explosion and the damage condition of its surrounding equipment.

The damage conditions of the surrounding equipment are shown in Figure 4-8. Six tanks which were located within the same dike as V-3138 were severely damaged together with several pumps installed near the west side of the dike. The six tanks were V-3116 (100m<sup>3</sup>: acrylic acid tank), V-3124 (50m<sup>3</sup>: toluene tank), V-3145B, V-3147B, V-3147C, and V-3148C (5m<sup>3</sup> each: inhibitor tanks). Furthermore, building (electric room) at the south side of the dike, nearby piperacks, piping, cables and fire engines were severely damaged also.

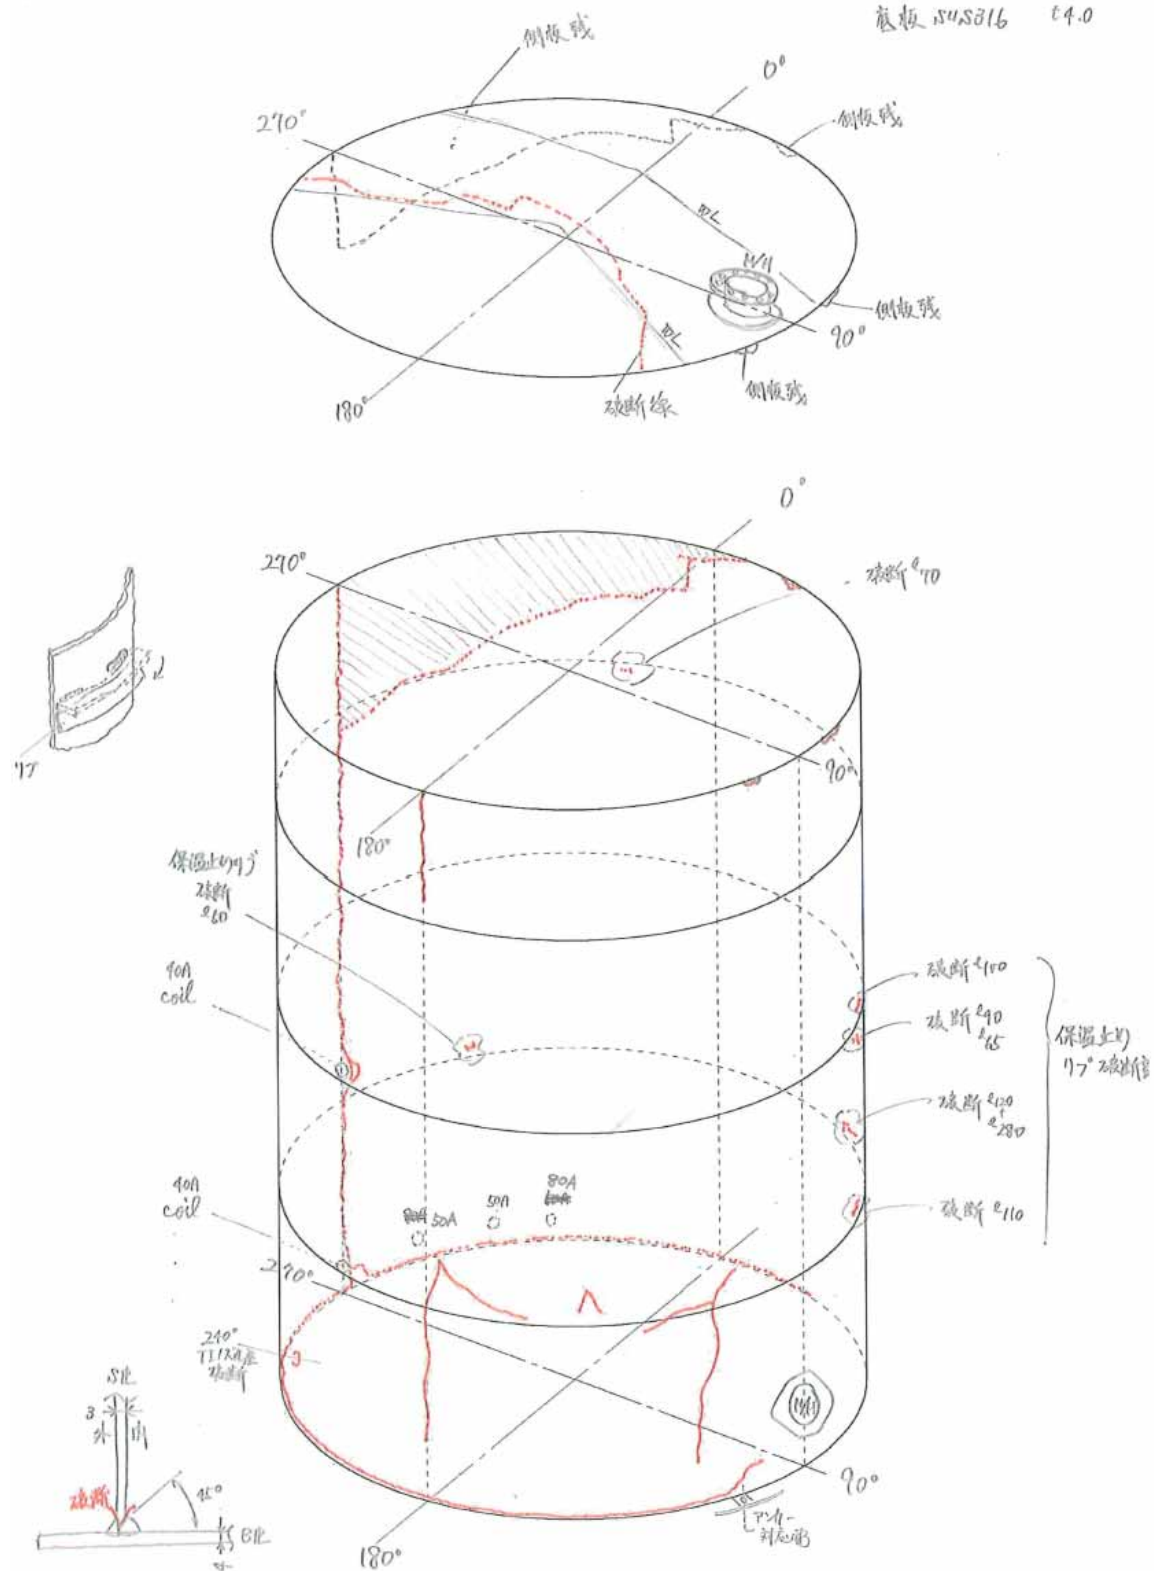
(Figure 4-9) Reconstruction diagram (sketch) of V-3138 fragments

The cracks formed in this part propagated and split the tank shell plate vertically in both directions at 270° position. The upwards crack broke into the roof plate and ran through it near the 135° position. The roof and bottom plates generally cracked in the circumferential direction near their joints with the shell plate. Figure 4-10 shows the estimated crack propagation paths of the roof and shell plate in development view.

About 80 pieces of broken fragments from V-3138 and surrounding equipment scattered within 100m radius. The tank contents were also scattered within 70m radius, particularly in the west direction of shell plate's opening (270° position).

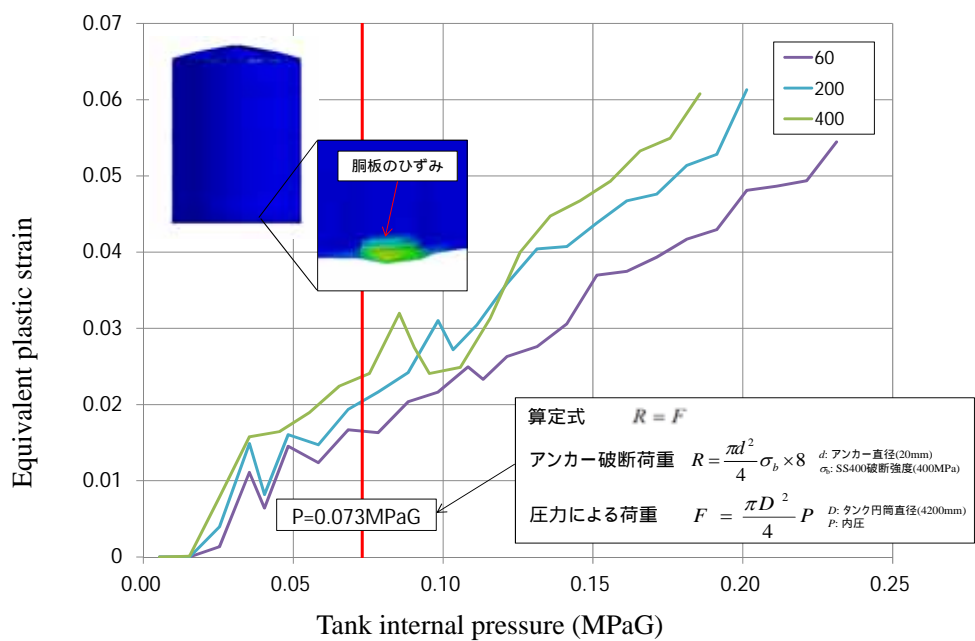
(Figure 4-13) Equivalent plastic strain on the tank surface caused by the tank internal pressure

Figure 4-13 shows the equivalent plastic strain on the tank surface caused by the tank internal pressure. Figure 4-14 shows the vertical reaction force acting on the anchors as a result of the tank internal pressure. The lower limit for the tank pressure to create the anchor breaking load of 1005kN was 0.073MPaG. The tank pressure at which the vertical reaction force exceeds the breaking load was estimated to be about 0.1MPaG. However, the strain on the shell plate at that time was about 2~3% which was not a level rupture would occur at the shell plate.

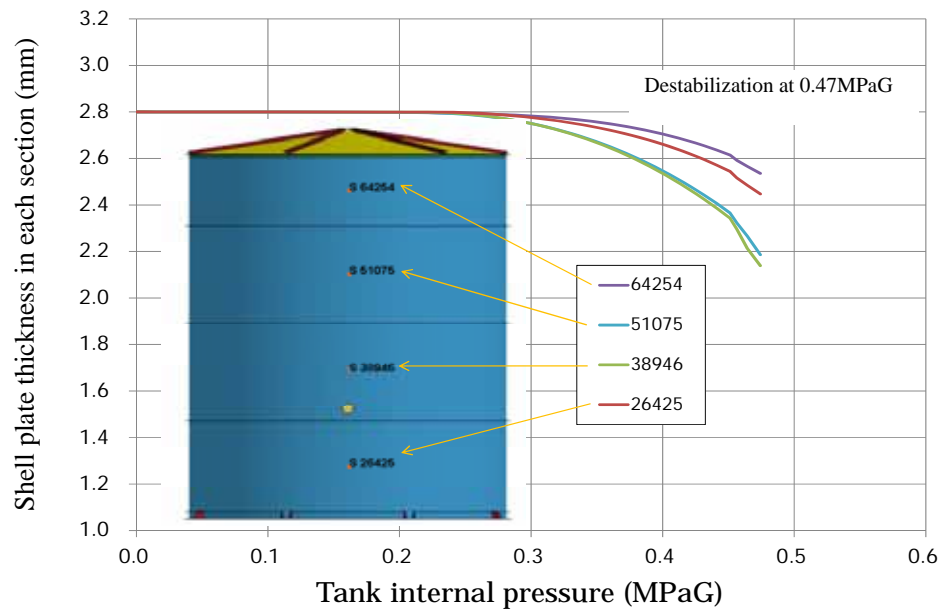
(Figure 4-15) Plate thickness reduction against the tank internal pressure by 3-D model (at 200°C)

The thickness of the ruptured V-3138 shell plate measured at about 2.8mm which was the same thickness as at the time of manufacture. Because of this, it was presumed that plate thickness reduction, which begins when the elastic limit of the material is exceeded, had not occurred. The pressure at which plate thickness reduction would become noticeable was estimated at about 0.25~0.30MPaG through structural analysis using the 3-D model. Figure 4-15 shows the results of plate thickness reduction against the tank internal pressure.

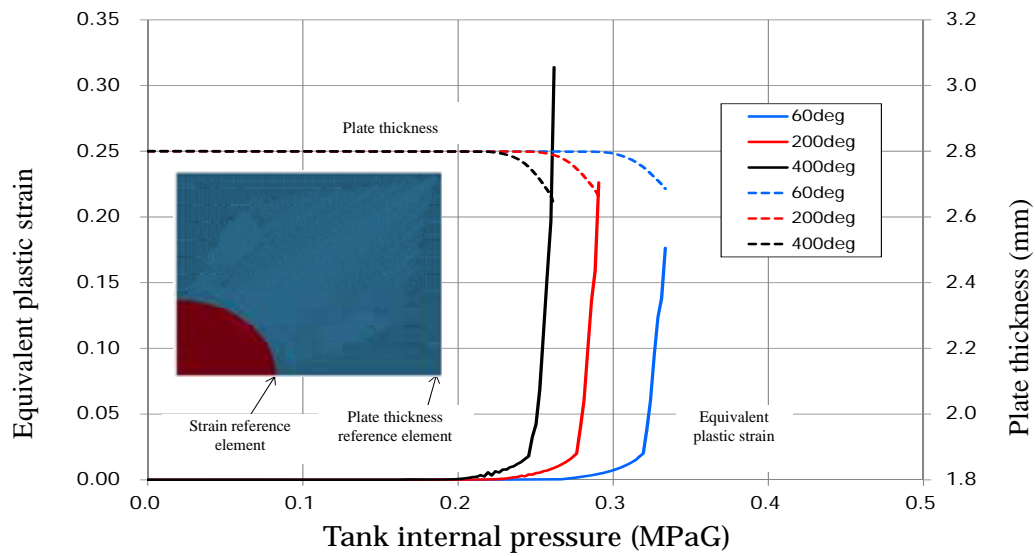
(Figure 4-18) Analysis results of cooling water outlet nozzle vicinity

In order to improve the analytical accuracy around this area, a local shell model was used to zoom-in the nozzle vicinity for estimating the pressure at which the plastic deformation increase indefinitely would occur. The pressure was estimated to be about 0.24~0.29MPaG. Figure 4-18 shows the results. The reason why the cracks appeared in this area is presumed due to a structural discontinuity at which a flange with a diameter of about 150mm and a plate thickness of about 8mm was attached to the shell plate. It is presumed that excessive stress and strain were developed near the structural discontinuity.

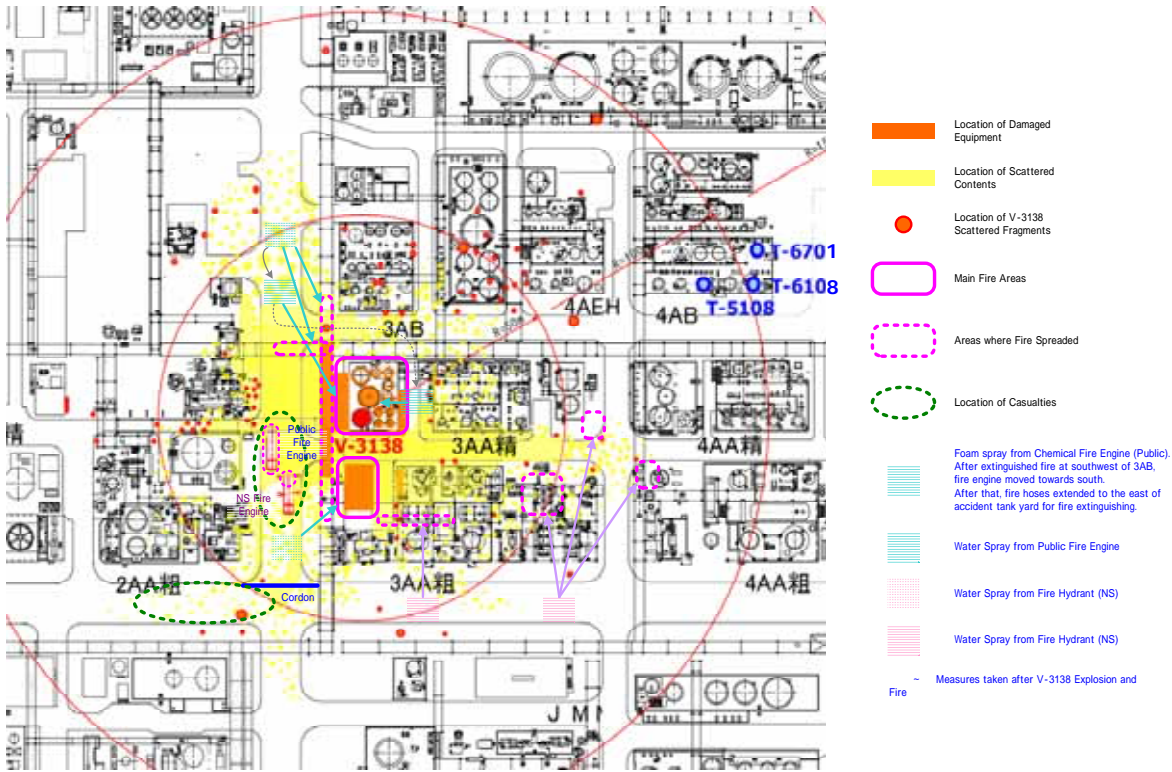
(Figure 4-19) Fire areas around the tank

This information is prepared based on the status confirmed after the accident and Nippon Shokubai (NS) employees interviews.

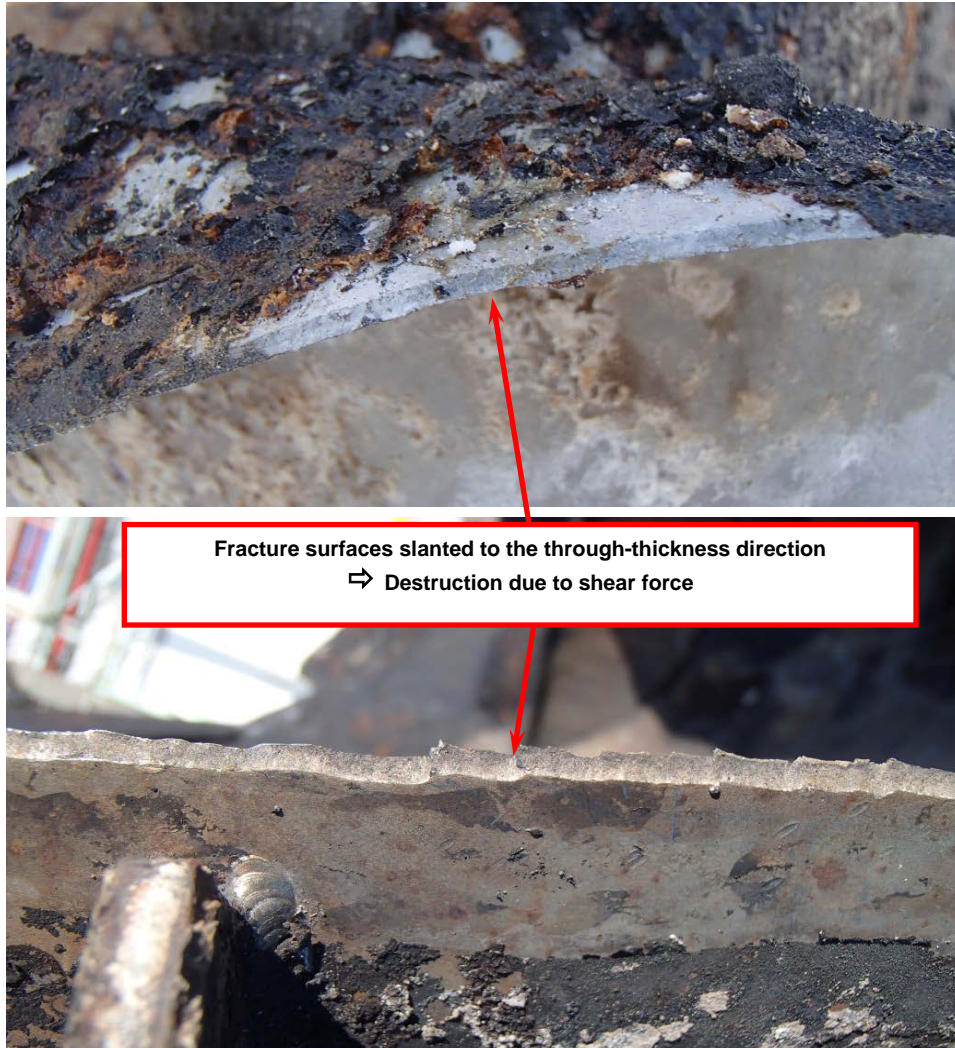
As shown in the figures below, the fracture surfaces are slanted to the through-thickness direction and formed through shear destruction caused by glide plane decohesion were extensively observed. The fact that shear fracture was extensively observed did not contradict the presumption of V-3138 destruction were developing at a fast rate.

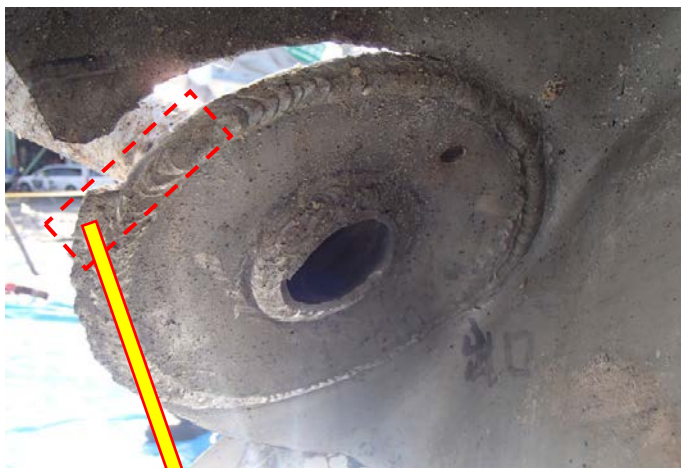
**Outlet nozzle of cooling water  
water  
(observed from outside)**

Based on the above observations, it is presumed that crack initiated due to ductile destruction on the exterior of flange outer circumference of cooling water coil outlet nozzle. The crack propagated vertically on the shell plate escaping from the flange outer circumference.

**Ductile fracture surfaces without  
shear fracture  
(dark area)  
⇒ Fracture surfaces formed due to  
tensile deformation (voids linkage)**

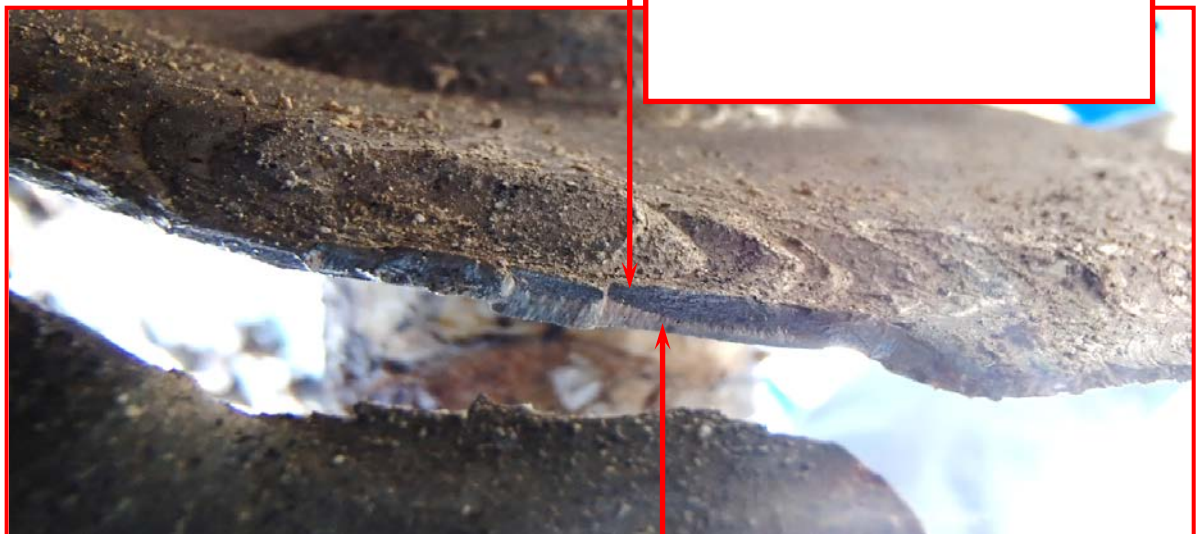
**Veined pattern in through-thickness direction  
⇒ Fracture surfaces due to crack propagation**
