Nippon Shokubai Co., Ltd. Himeji Plant

Explosion and Fire at Acrylic Acid Production Facility

Investigation Report

March 2013

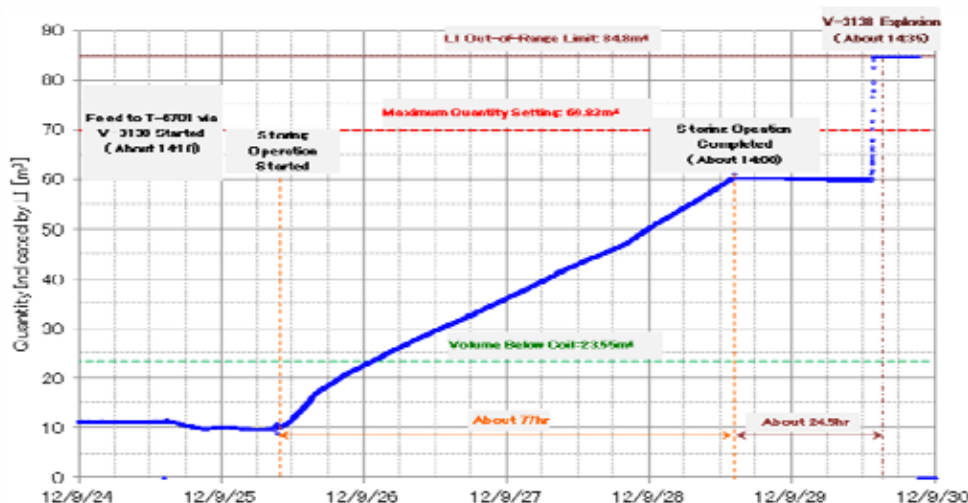
(Figure 4-6) Trend of V-3138 liquid level gauge (until the explosion)

The V-3138 liquid level gauge reading (pressure differential type) has shown increasing trend. It started to rise at about 13:20, reached the maximum liquid volume setting at about 13:30 and exceeded the gauge's out-of-range limit (84.8m<sup>3</sup>) at about 13:40. This trend has shown the V-3138 internal pressure has increased. The increasing pressure is presumed to have occurred because the vent's discharge capacity has exceeded by the increased amount of evaporated vapor resulted from accelerated polymerization. Figure 4-6 shows the V-3138 liquid level trend.

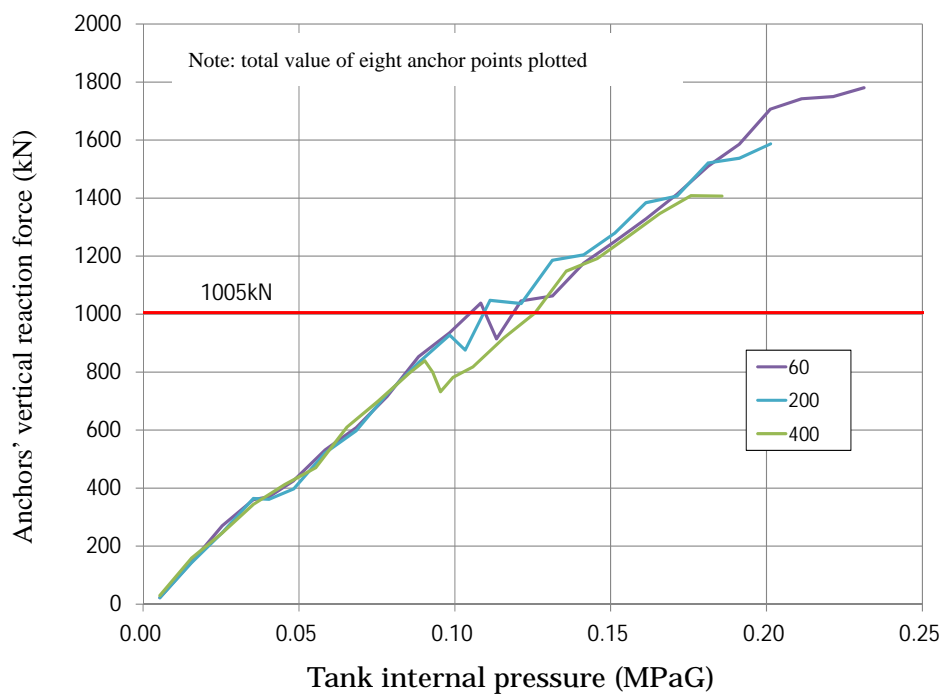
(Figure 4-14) Vertical reaction force acting on the anchors as a result of the tank internal pressure

Figure 4-13 shows the equivalent plastic strain on the tank surface caused by the tank internal pressure. Figure 4-14 shows the vertical reaction force acting on the anchors as a result of the tank internal pressure. The lower limit for the tank pressure to create the anchor breaking load of 1005kN was 0.073MPaG. The tank pressure at which the vertical reaction force exceeds the breaking load was estimated to be about 0.1MPaG. However, the strain on the shell plate at that time was about 2~3% which was not a level rupture would occur at the shell plate.
