Nippon Shokubai Co., Ltd. Himeji Plant

Explosion and Fire at Acrylic Acid Production Facility

Investigation Report

March 2013

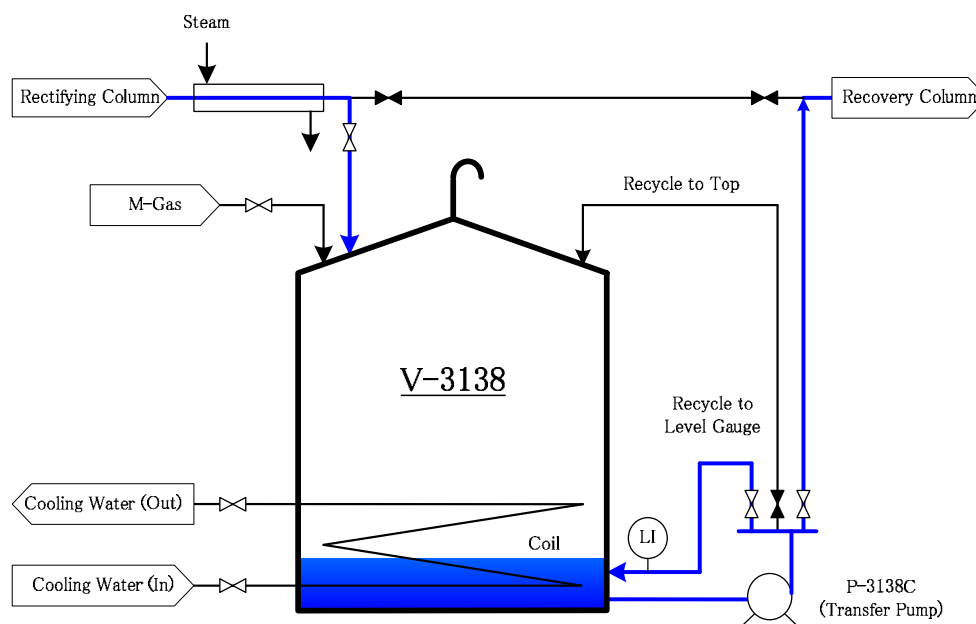
(Figure 4-1) Status of tank V-3138 before liquid storing

The transfer piping of T-5108 bottom liquid was steam jacketed to prevent plugging due to precipitation. The temperature of the bottom liquid as it entered V-3138 was estimated at about 100°C, based on steam temperature and the length of the jacketed piping.

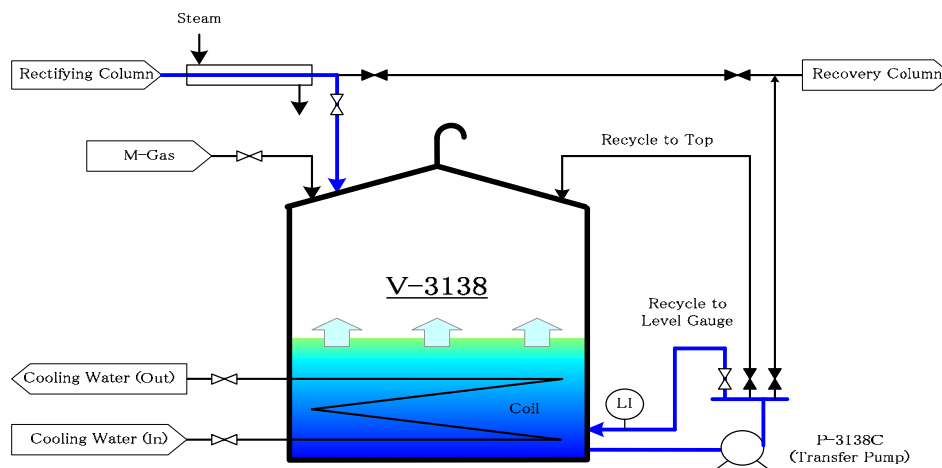
(Figure 4-2) Status of tank V-3138 during liquid storing

The volume of liquid in V-3138 reached the planned 60m<sup>3</sup> at about 14:00 on September 28, approximately 77 hours after the commencement of storage. During this period, the circulation of Recycle to Top was not commissioned. Figure 4-3 shows the V-3138 liquid level trend during storing operation. The coil cooled the liquid in the bottom of V-3138 but was unable to cool the liquid above the top of the coil effectively. This had created an uneven temperature distribution in the vertical direction of V-3138 liquid. It is presumed that this relatively high temperature section has led to the reaction of forming acrylic acid dimer (diacrylic acid, referred to as “DAA”). With the heat of this reaction, V-3138 liquid temperature has increased steadily. However, V-3138 was not equipped with any thermometer and it was not possible to detect the temperature has increased.

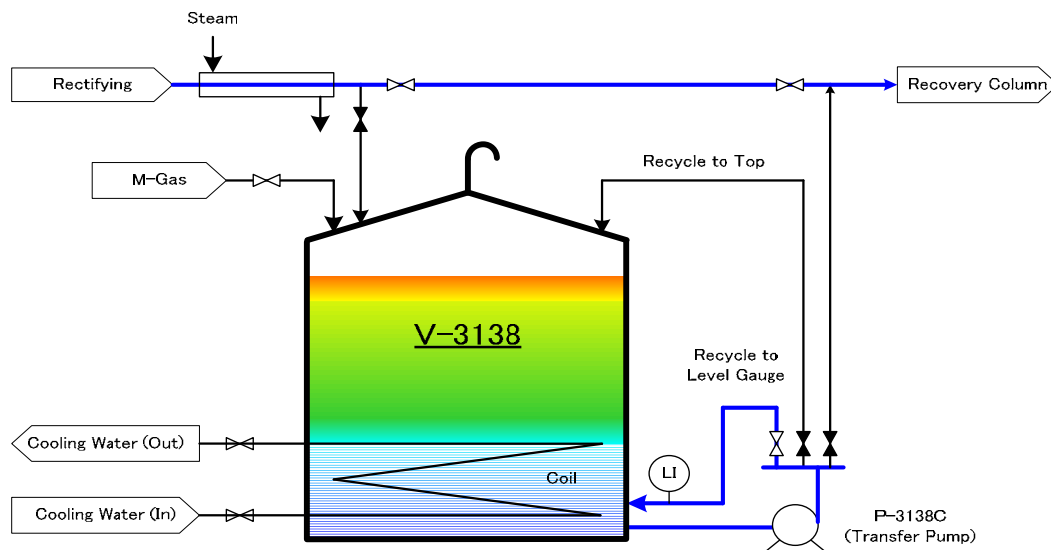
(Figure 4-4) Status of tank V-3138 after liquid storing

Even then, the circulation of Recycle to Top was still not commissioned. Consequently, the liquid above the top of the coil was not cooled and remained at a relatively high temperature. In order to simulate the temperature distribution in the V-3138 liquid, a 3-D model of V-3138 was developed. The ANSYS Fluent Ver.13 was used to conduct the fluid analysis without taking the heat of reaction into consideration. The analysis showed that if Recycle to Top was not commissioned, the liquid just below surface remained at a relatively high temperature, average about 87°C immediately after reaching a volume of 60m<sup>3</sup>. The analysis results are shown in Figure 4-5.

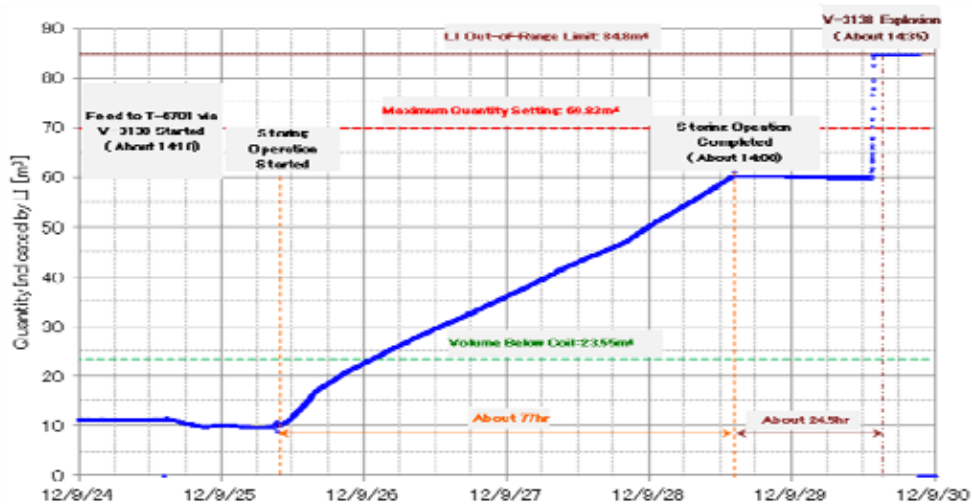
(Figure 4-6) Trend of V-3138 liquid level gauge (until the explosion)

The V-3138 liquid level gauge reading (pressure differential type) has shown increasing trend. It started to rise at about 13:20, reached the maximum liquid volume setting at about 13:30 and exceeded the gauge's out-of-range limit (84.8m<sup>3</sup>) at about 13:40. This trend has shown the V-3138 internal pressure has increased. The increasing pressure is presumed to have occurred because the vent's discharge capacity has exceeded by the increased amount of evaporated vapor resulted from accelerated polymerization. Figure 4-6 shows the V-3138 liquid level trend.

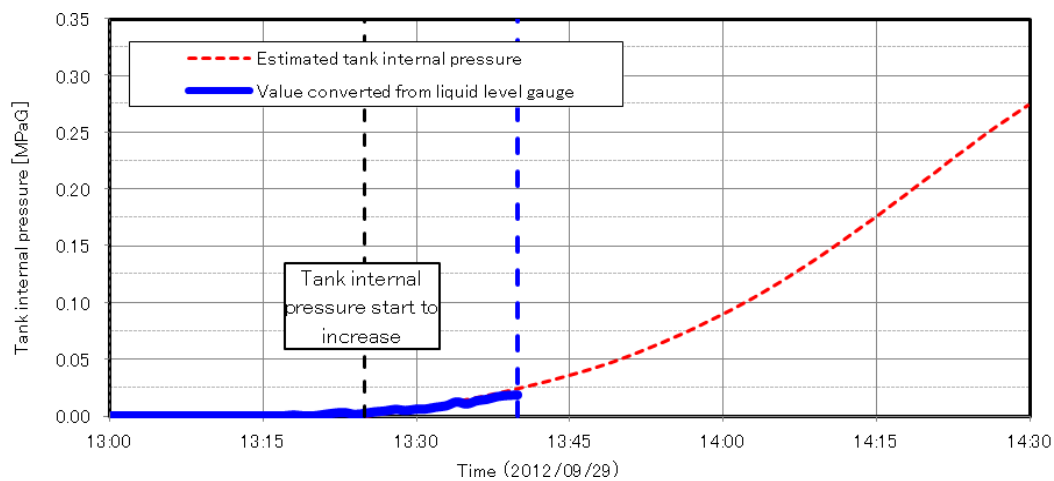
(Figure 4-7) V-3138 liquid level gauge readings (converted to pressure) and pressure rise

The V-3138 pressure continued to rise thereafter and cracks appeared at the shell plate. It is estimated the pressure had built up to 0.24~0.29MPaG based on tank structural analysis at the time the cracks appeared. Independently, based on the adiabatic polymerization experiment data, the V-3138 internal pressure was also estimated to reach about 0.27MPaG. The estimated trend of increased pressure is shown in Figure 4-7 and the model used for estimation is explained in Appendix 2. Also, the V-3138 liquid was estimated to be about 230~240°C in the high temperature zone. The reaction data of the adiabatic reaction test is explained in Appendix 1 and the structural analysis results will be discussed in Section 4.2.1.

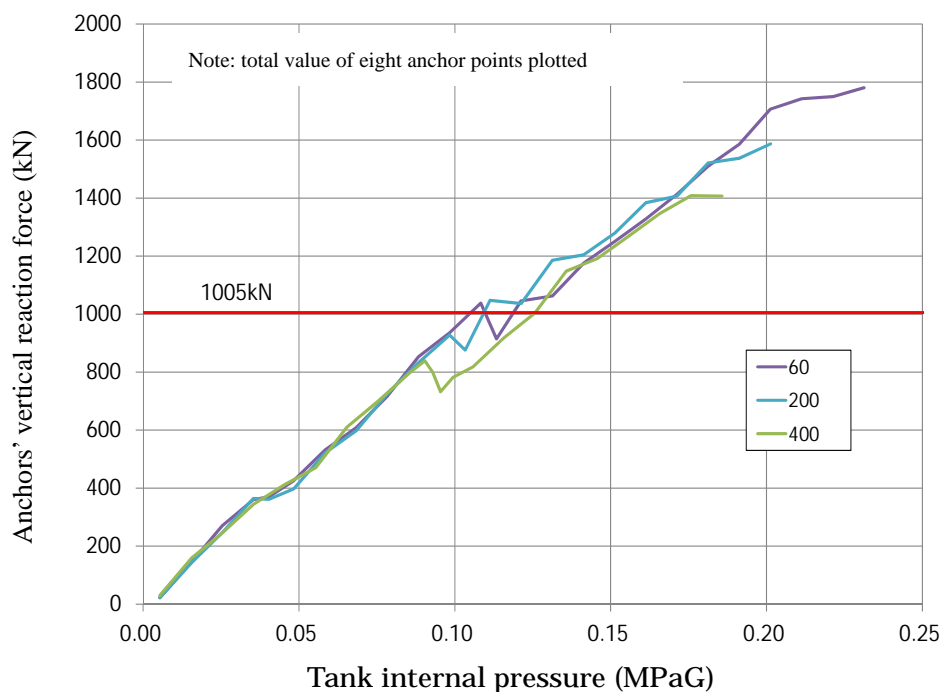
(Figure 4-14) Vertical reaction force acting on the anchors as a result of the tank internal pressure

Figure 4-13 shows the equivalent plastic strain on the tank surface caused by the tank internal pressure. Figure 4-14 shows the vertical reaction force acting on the anchors as a result of the tank internal pressure. The lower limit for the tank pressure to create the anchor breaking load of 1005kN was 0.073MPaG. The tank pressure at which the vertical reaction force exceeds the breaking load was estimated to be about 0.1MPaG. However, the strain on the shell plate at that time was about 2~3% which was not a level rupture would occur at the shell plate.

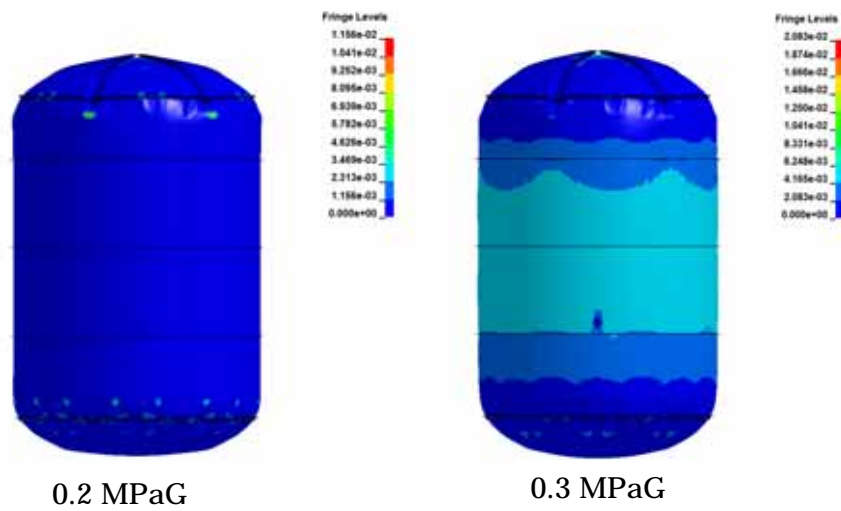
(Figure 4-16) Strain analysis by 3-D model (at 200°C)

Presuming the cracks initiated before reaching this pressure, the structural analysis was conducted focusing on the tank's weak points. These included the nozzles of cooling water coil, roof-to-shell joints, shell-to-bottom joint and the edges of the tank. The results have confirmed a larger strain appeared locally at the outlet nozzle of cooling water coil than its surrounding. Figures 4-16 and 4-17 show the analysis results.

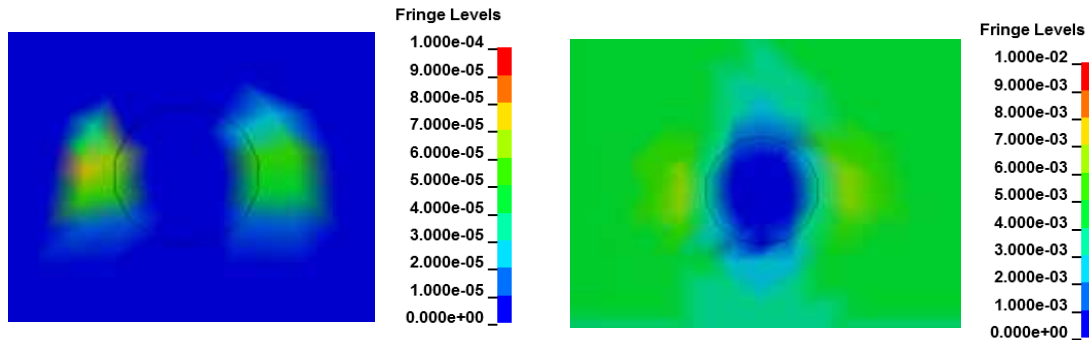
(Figure 4-18) Analysis results of cooling water outlet nozzle vicinity

In order to improve the analytical accuracy around this area, a local shell model was used to zoom-in the nozzle vicinity for estimating the pressure at which the plastic deformation increase indefinitely would occur. The pressure was estimated to be about 0.24~0.29MPaG. Figure 4-18 shows the results. The reason why the cracks appeared in this area is presumed due to a structural discontinuity at which a flange with a diameter of about 150mm and a plate thickness of about 8mm was attached to the shell plate. It is presumed that excessive stress and strain were developed near the structural discontinuity.

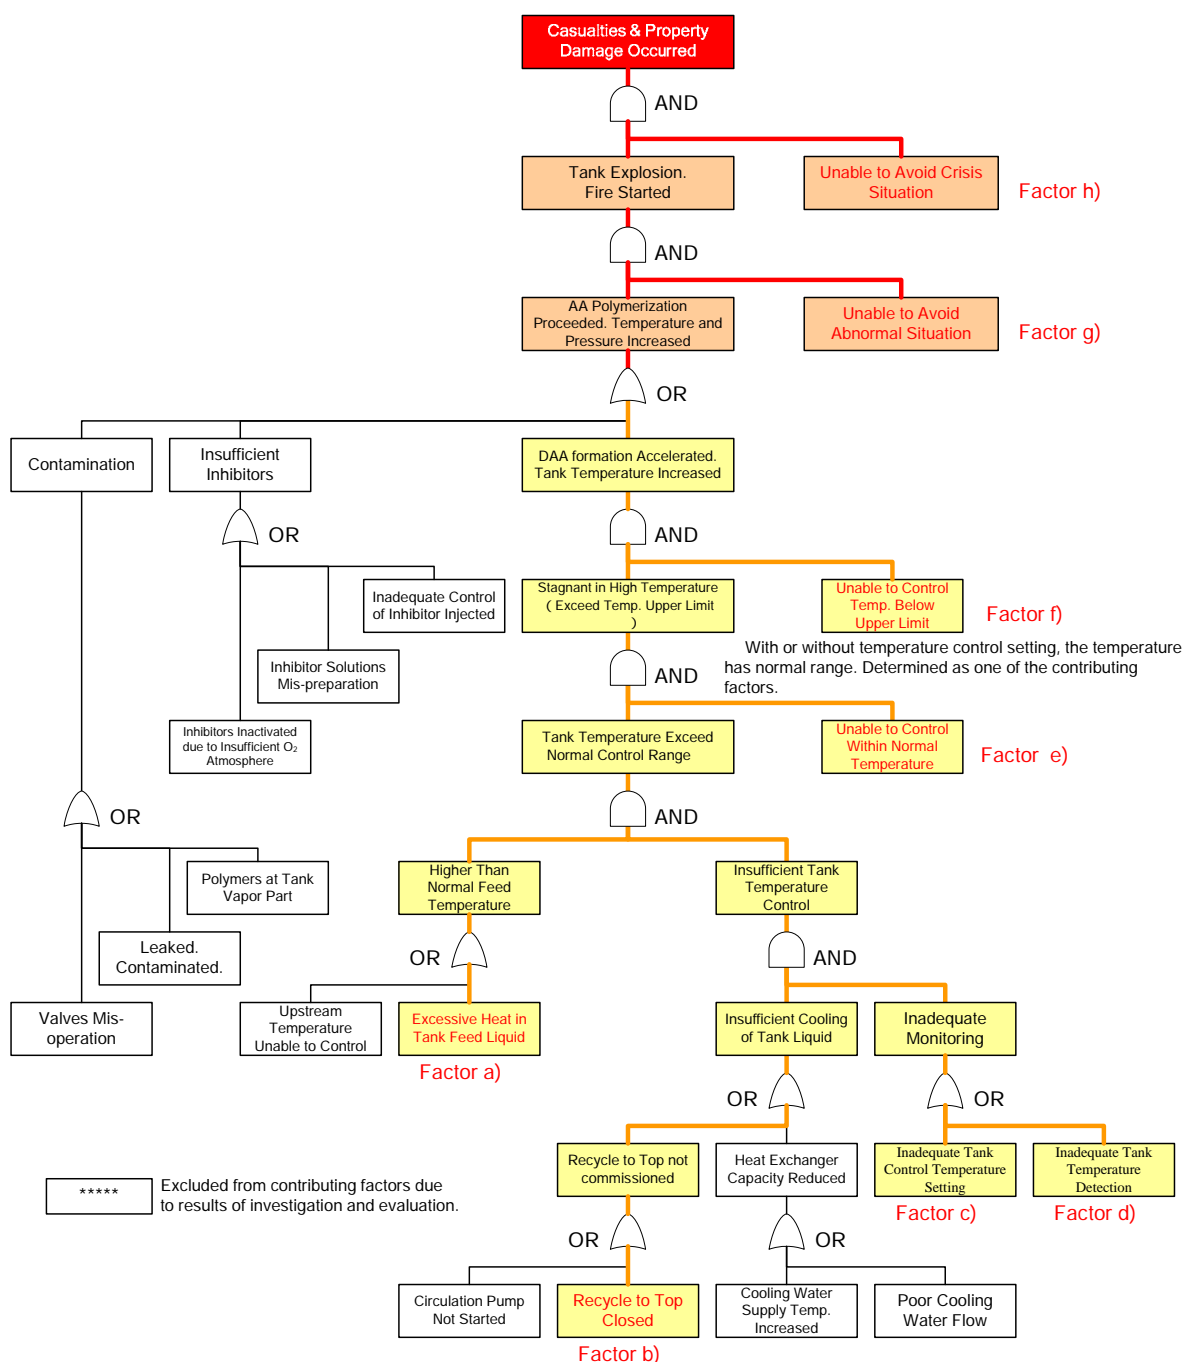
(Figure 5-1) Fault Tree Diagram (FT Diagram) of Contributing Factors

In light of the direct causes of the accident, an FT diagram was used to systematically analyze events in order to clarify contributing factors that could have caused the accident and their connections. The results are shown in Figure 5-1. The following eight items are determined as contributing factors that caused the accident:

No criteria were developed to judge the symptom and abnormality of tank temperature. Also the response procedures to handle abnormal situations were not established.

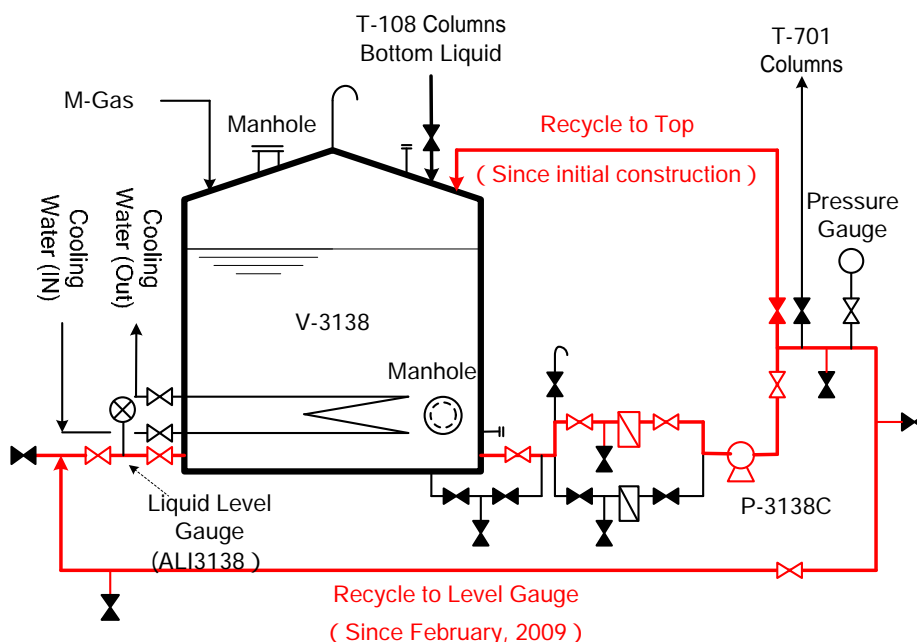
(Figure 5-3) V-3138 status before the accident

- (2) Contributing factor b) -1) Recycle to Top valve was closed (V-3138 Control Procedure)

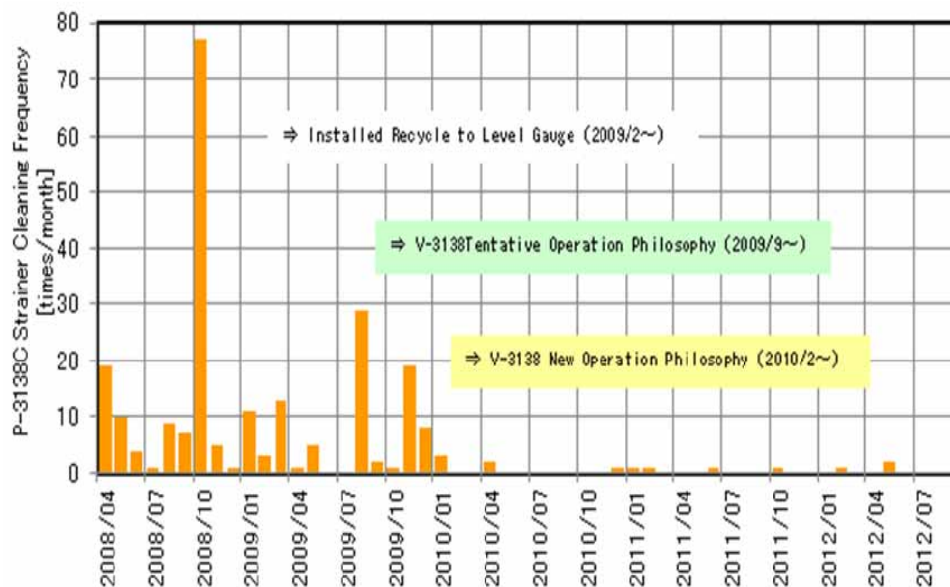
(Figure 5-4) Frequency of P-3138C strainer cleaning

After changing to V-3138 Control Procedure, the frequency of cleaning the pump strainer has dropped sharply. This has significantly reduced the workload of operators. Moreover, the tank internal has not been washed since the last cleaning in August 2009. Figure 5-4 shows the frequency of pump strainer cleaning.

Originally, the cleaning and washing works around V-3138 is due to the precipitate accumulation inside the tank. By changing the procedures of operating the tank, the effectiveness of this improvement has verified by the reduced frequency in strainer cleaning, etc. However, any change in the amount of deposition inside the tank and the need for Recycle to Level Gauge was not re-examined.

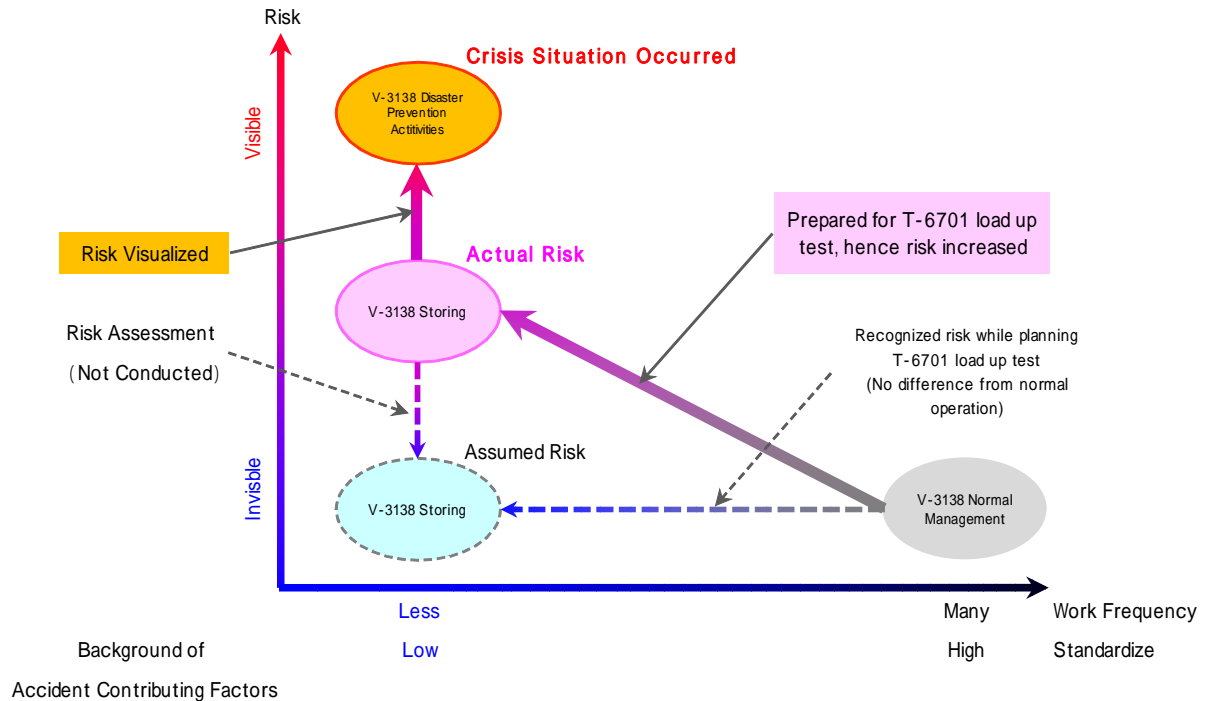
(Figure 5-5) Summary of background of accident contributing factors

Based on the above, the backgrounds of each contributing factor are summarized in the Figure 5-5. Also, each of the contributing factors, management elements of its background and consideration to prevent recurrence are summarized in Table 5-2.

- (1) Insufficient design review and design philosophy handover procedures
- (2) Insufficient operation manuals development and dissemination
- (3) Weak systems in safe work management and risk evaluating of changes, non-routine works
- (4) Inadequate management of operating conditions settings
- (5) No establishment of criteria for abnormal and crisis situations and its respective response procedures
- (6) Poor coordination with public fire department during disaster prevention activities

Safety culture and safety climate issues that derived from the above backgrounds  
(Safety awareness and hazards sensibility, etc.)  
(Lack of understanding of technical knowledge, expertise and hazardous information)

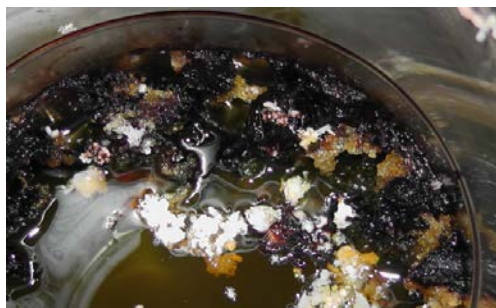
Internal of Dewar Flask

Floating Polymers (black, white): 31g

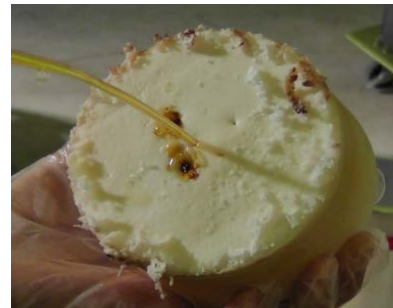
Lid of Dewar Flask (silicone stopper)

White polymers at the back of the lid

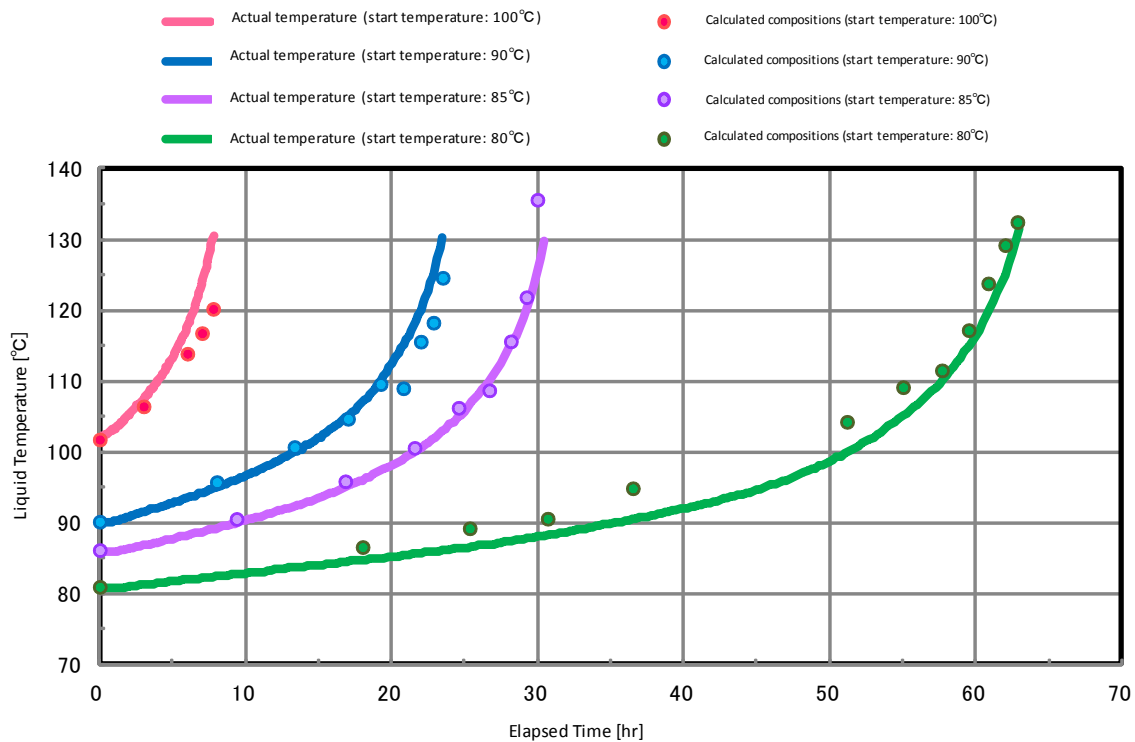
#### 1. Difference in temperature curves due to start temperature and atmosphere

※ During the liquid storing operation in V-3138, it took about 60 hours to reach 60 m3 from 25 m3 and about 80 hours to discover the white smoke. The experiment data with comparatively long elapsed time (start temperature: 80°C) was used to estimate the tank internal temperature.

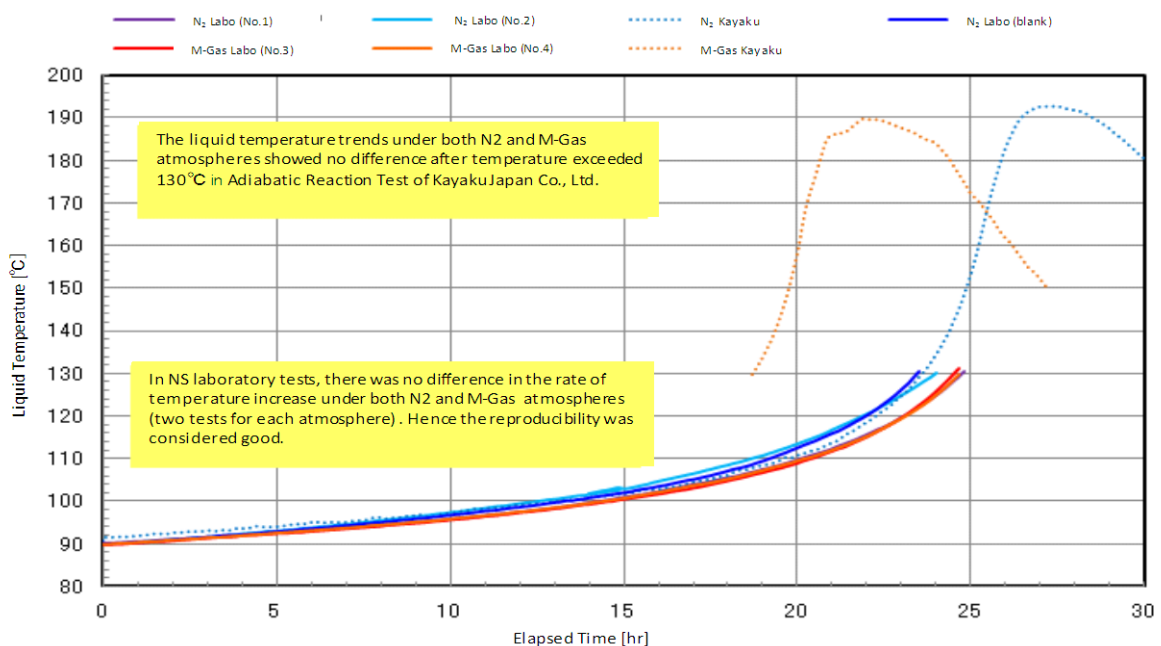
#### 2. Difference in temperature curves due to atmosphere

⇒ Through a series of reactions, it has not found any difference in temperature curves due to different atmospheres. Therefore, it is presumed that the atmosphere inside the tank did not influence the accident in the Himeji Plant.

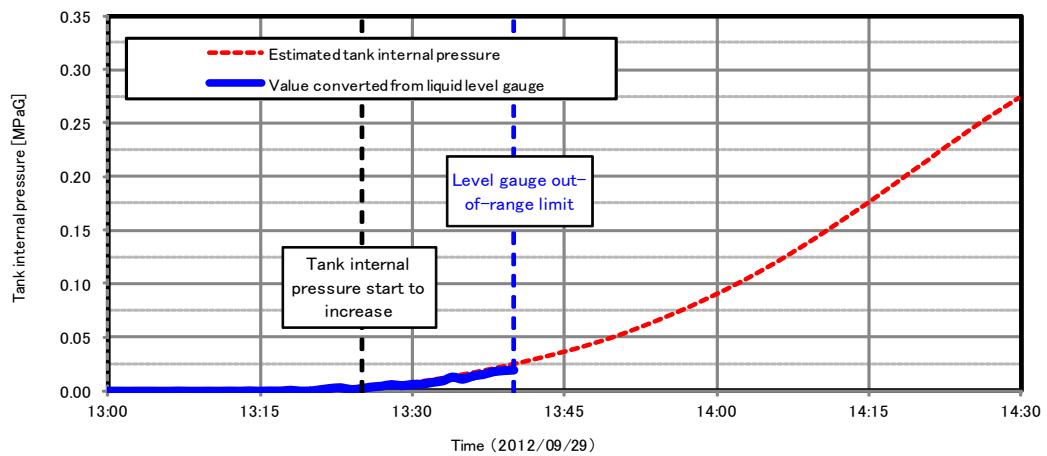
#### i. Estimated tank internal pressure

Estimated internal pressure at the time that crack initiated on tank: about 0.274MPaG (structural analysis result: 0.24 to 0.29MPaG)

※About 14:35, cracks initiated on tank

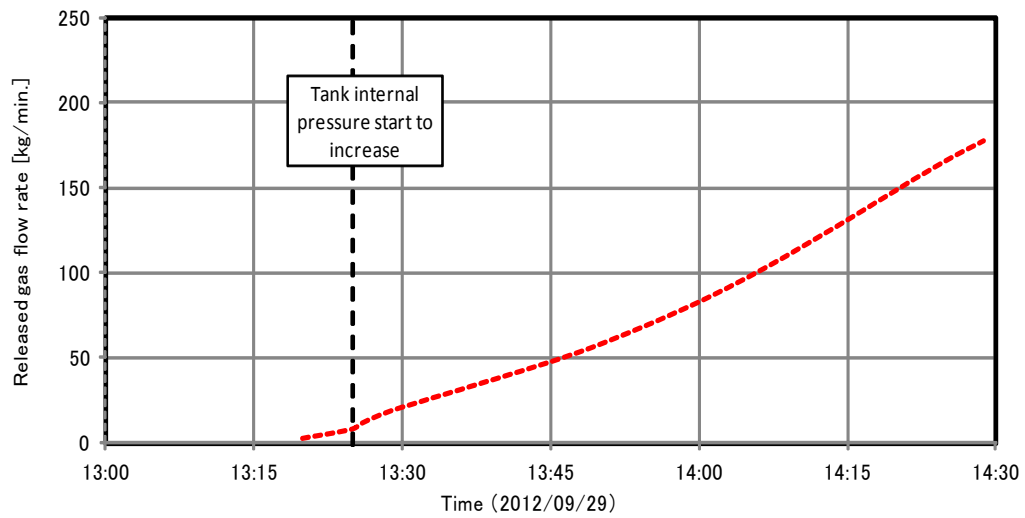
ii. Estimated released gas flow rate

⇒ The gas velocity at the vent outlet when the tank ruptured was estimated at 248m/sec. On the other hand, the sonic velocity of acrylic acid gas at temperature of 233°C was estimated at 250m/sec. We therefore confirmed that it was not within the range of affecting the estimated internal pressure.

※About 14:35, cracks initiated on tank

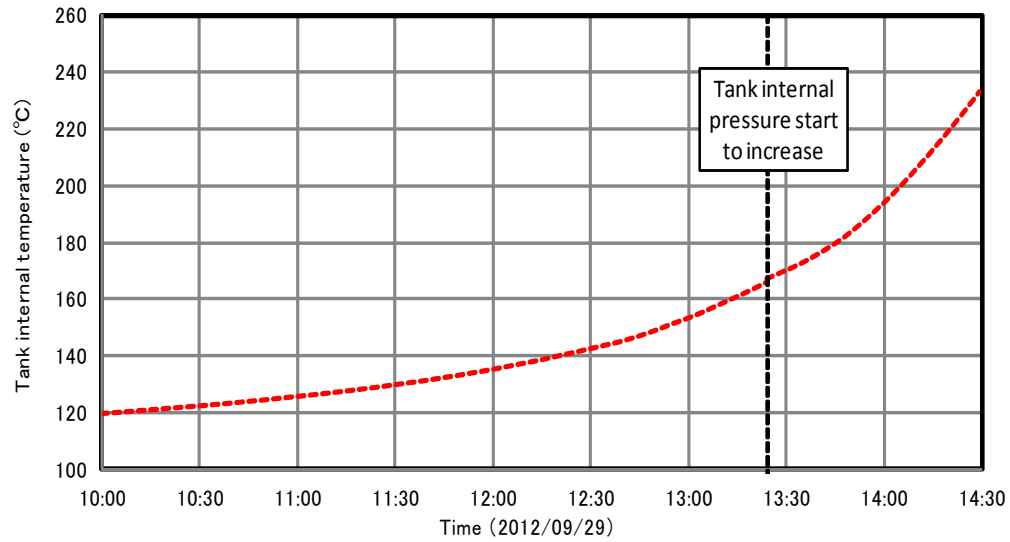
iii. Estimated tank internal temperature

※About 14:35, cracks initiated on tank
